VENOM FB.1. WE.258
(GHOST 3)

4 X 20 MM. MK.5th HISPANO GUNS
GUNNERY ACCEPTANCE TRIALS

10th Part of Report No. AAEE/868

30. JAN. 1953

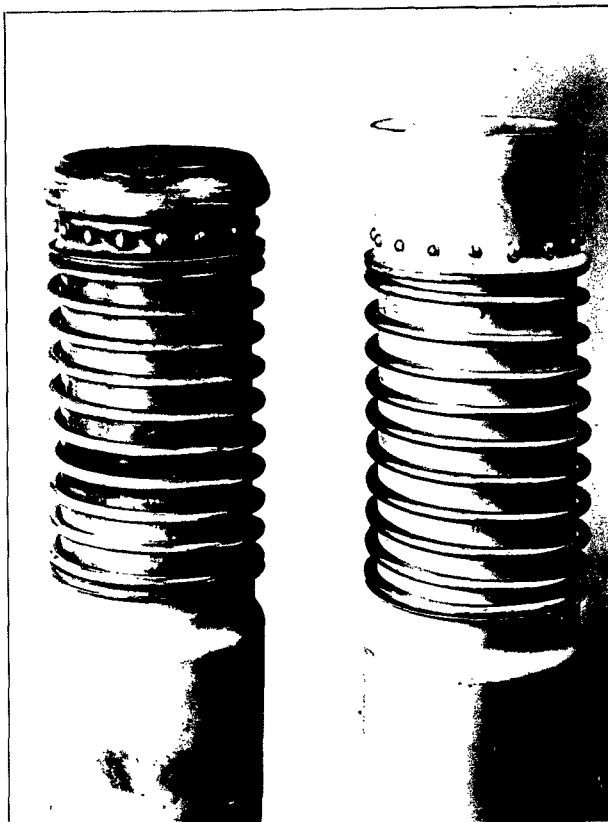
4.6.2. A modified blast tube was evolved by the Martin Baker Aircraft Co. which was found to be satisfactory. Approximately 50 firing sorties were carried out with this type mostly at speeds of 500 knots and over. Fig. 7 shows the original and modified types. The maker's drawing No. of the modified type is MBT60/5350.

FIG. 7 STANDARD AND MODIFIED
BLAST TUBE

6.2. Blast tubes of the modified MBT/60 pattern with the Edge Type Rim to the Martin Baker Aircraft Company's drawing No. MBT/60/M5350 should be fitted as standard. Until this is done blast tubes should be checked for damage after each air firing sortie.

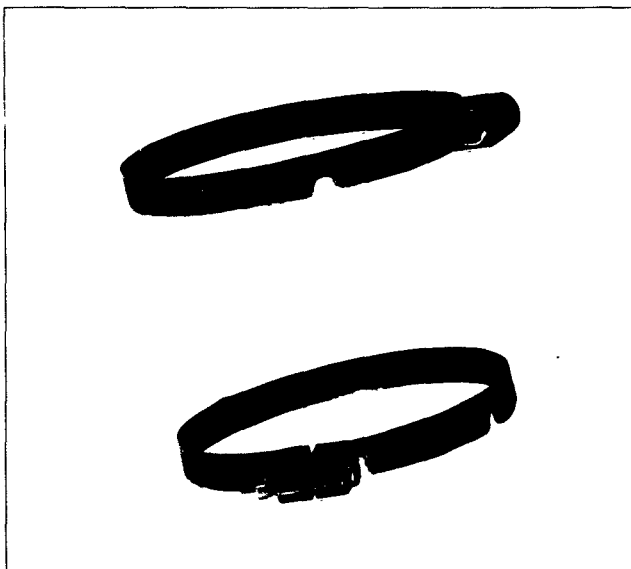
4.6.4. The present method of securing the blast tubes to the front mountings of the guns is not considered strong enough. In two cases the jubilee clips fractured across the out-away portion giving clearance for the outer eccentric lock. It is considered that a clip similar to that shown in fig. 8 should be introduced. This clip is re-inforced at its narrowest part and is secured by a nut and bolt.

FIG. 8 SUGGESTED TYPE OF MODIFIED BLAST
TUBE SECURING CLIP

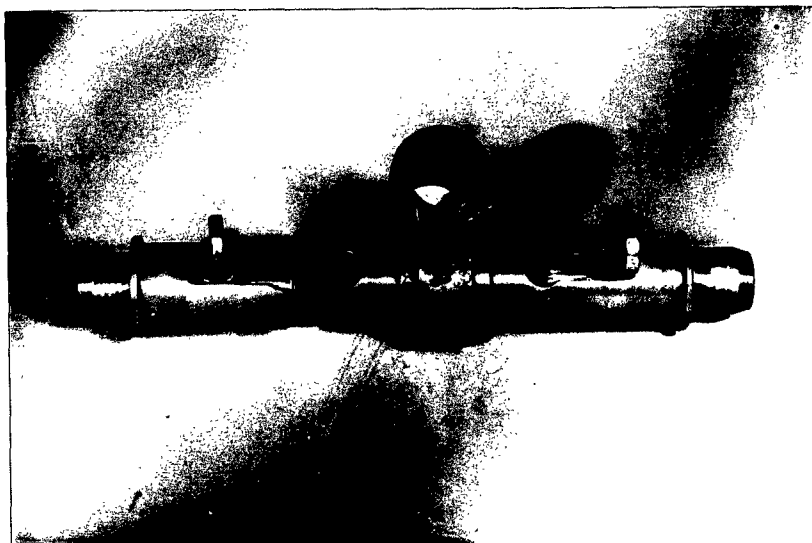
4.4.8. After the 34th sortie it was found that the quick release assembly at the rear mounting (Stores Ref: 26FC/4028) was fractured (Fig. 9). Two other quick release assemblies were changed due to the slide tubes becoming slack in the brackets.

FIG. 9. FRACTURED QUICK RELEASE ASSEMBLY
AT REAR MOUNTING.

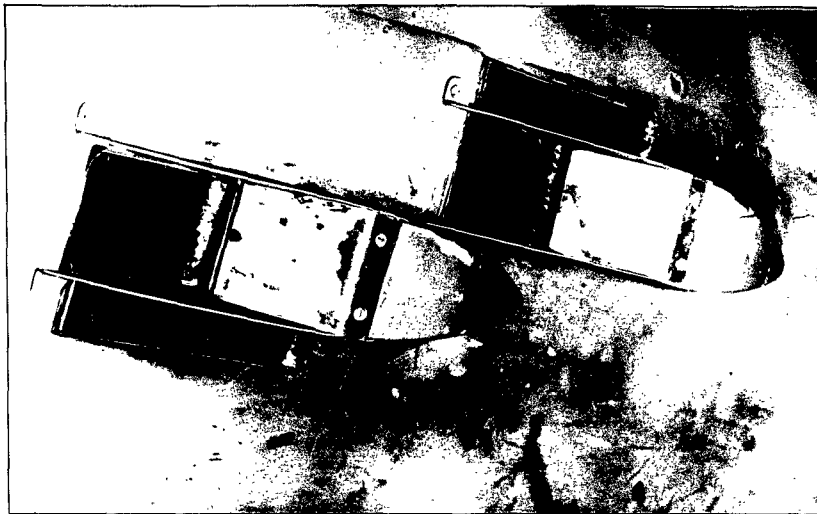
4.4.2. No stoppages occurred which were attributable to the installation with the exception of those during the first air firing sortie. These four stoppages were caused by the original link deflectors which have been rejected.

FIG. 12. ORIGINAL D.H. DEFLECTOR.

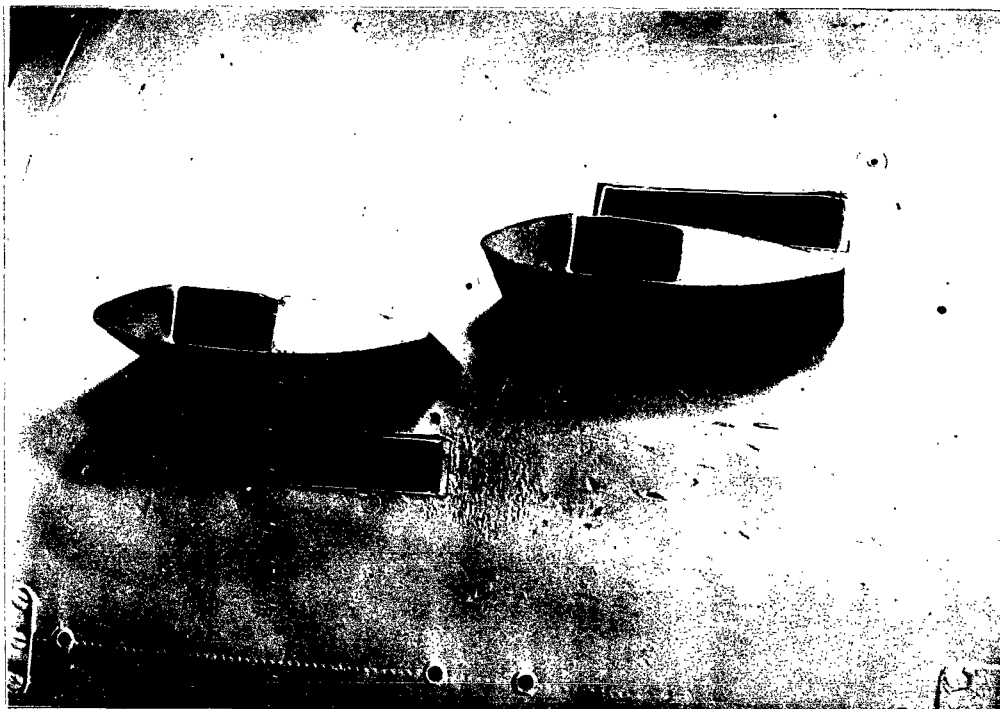
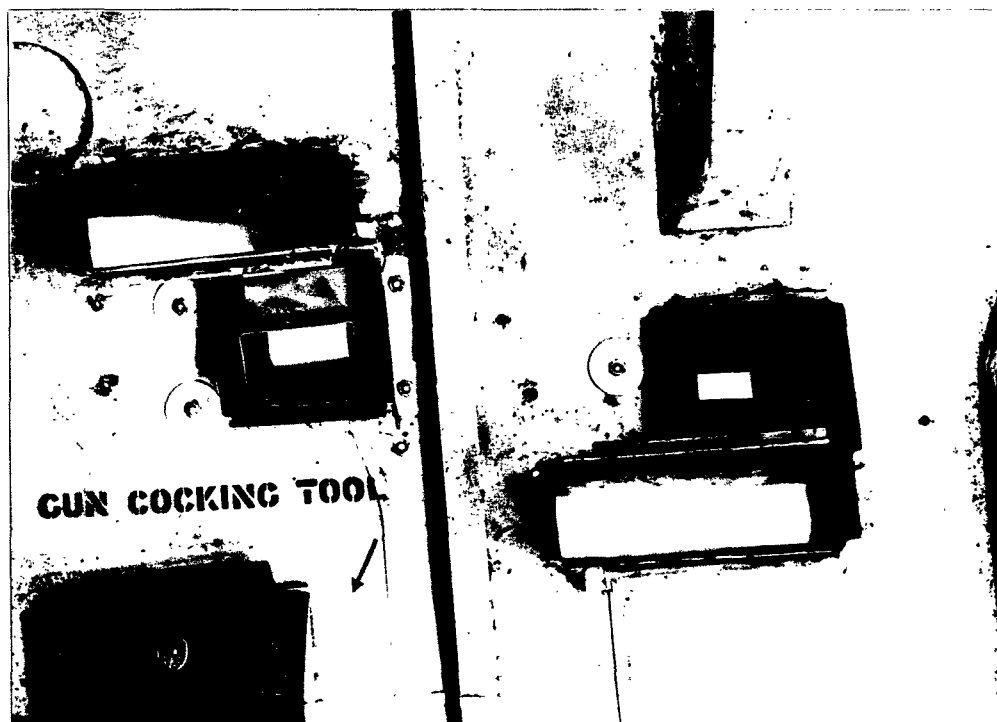
5	Extension link chutes fitted to gun access doors to reduce size of ejection opening to that of link chute. 4½" streamlined deflectors. Designed by D. H. Aircraft Co.	15 & 16	500-530 kts. 'G' conditions and full combat manoeuvres	8	1 link strike in 8 sorties. Inner ends of extension link chutes required bellowing out to allow for adjustment of B.F.M.s.	Deflectors found by subsequent trials to be larger than necessary. Link chutes may foul extension chutes after a gun change or harmonisation.
6	As for type 5 but with 3½" deflectors	15 & 16	500-530 kts. 'G' conditions and full combat manoeuvres	7	4 link strikes in 7 sorties. 6 strikes on starboard flap after 1st sortie may have been from a previous sortie.	As for type No. 5.
7	As for type 5 but with 2½" deflectors	17	500-530 kts. 'G' 5 conditions & full combat manoeuvres.	5	2 link strikes in 5 sorties.	Deflector accepted.
8	As for type 5 but with inner end of extension link chute belled out and with 2" deflector.	18	500-530 kts. & 'G' conditions	5	5 - 6 link strikes per sortie at 520 knots. I.A.S. and over.	Deflector rejected, too many link strikes. Extension link chute accepted.

FIG. 15. REDESIGNED D.H. DEFLECTOR.
EXTERNAL VIEW.

FIG. 16. REDESIGNED D.H. DEFLECTOR.
INTERNAL VIEW.

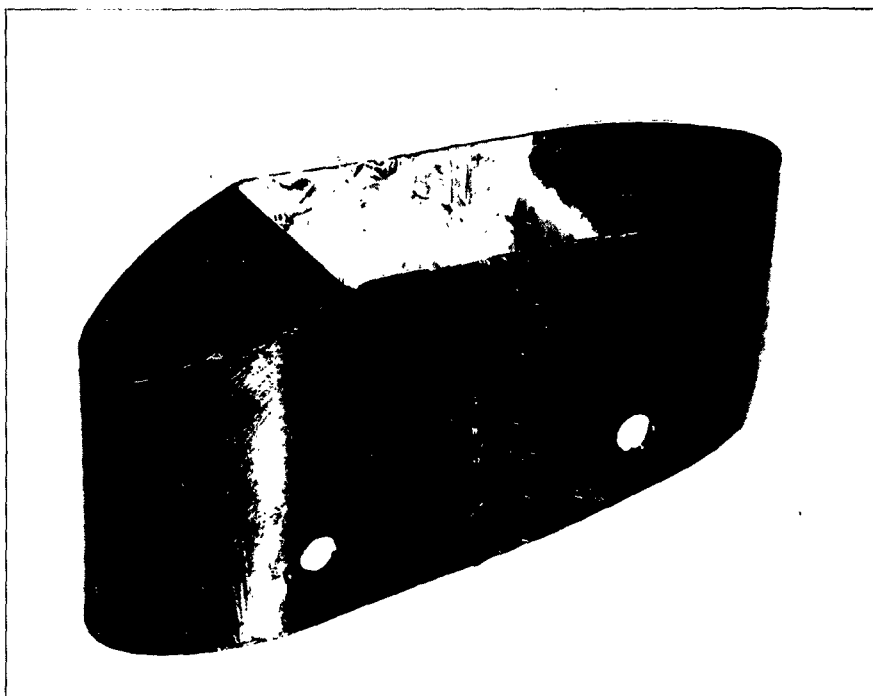
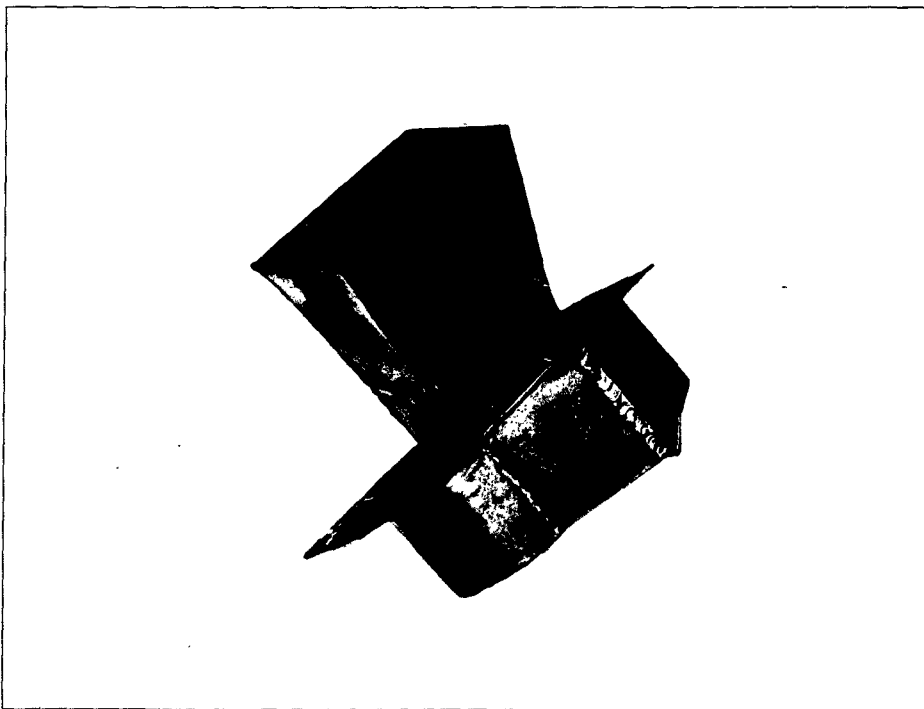
4.7.4. A link deflector consisting of an extension link chute fitted to the gun access door and an external deflector was found to be satisfactory. The extension chute fits over the end of the link chute from the B.F.M. and is belled out at the inner end to allow for movement of the link chute during harmonisation and gun changes. The deflector is of approximately streamlined section and has a maximum depth of 2½". Fig. 17 shows the deflector and fig. 18, the extension link chute. The aircraft's performance at high mach number is not affected by these deflectors. (See appendix 4).

9	Extension link chute as in type No. 8 with 2½" deflector as in type No. 7.	17 & 18				Accepted.

FIG. 17. 2½ FAIRING FOR LINK DEFLECTOR.
NOTE: INTERNAL SURFACES PAINTED
WHITE FOR ILLUSTRATION ONLY.

FIG. 18. FINAL INTERNAL FORM OF
DEFLECTOR FITTED WITH 2" FAIRING.

6.1. Link deflectors of the type shown in the De Havilland Aircraft Company's drawing "D.H.112 Link Chute Extensions" drawing No. 122.2345 but with the 2 $\frac{1}{2}$ " fairings produced by that firm, must be fitted as standard. The underside of the fuselage, the booms and tailplane must be checked for damage after each air firing sortie.
